Streak Artifacts due to Change in Reconstruction Parameters in CT in PET-CT Image Acquisition

Homi Bhabha Cancer Hospital & Research Centre, Visakhapatnam, India

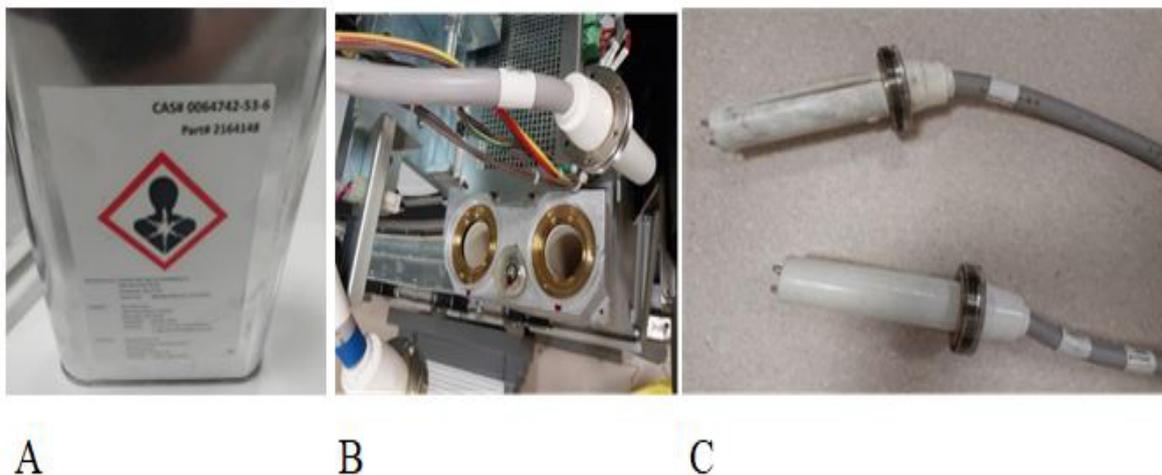
Figure 1: a) Dielectric Oil b) placement zone c) HV cathode cables

We immediately made a call to service engineer and find insufficient dielectric oil [Figure :1(a)] and while opening CT gantry for filling the dielectric oil to the CT tubes he found breakdown at the HV cathode cable [Figure 1c]. Immediately placed an order for the spare part and replaced it on an emergency basis. After that service engineer done all CT QA and QC calibration procedures but later we again found the same artifacts on the CT Trans axial images

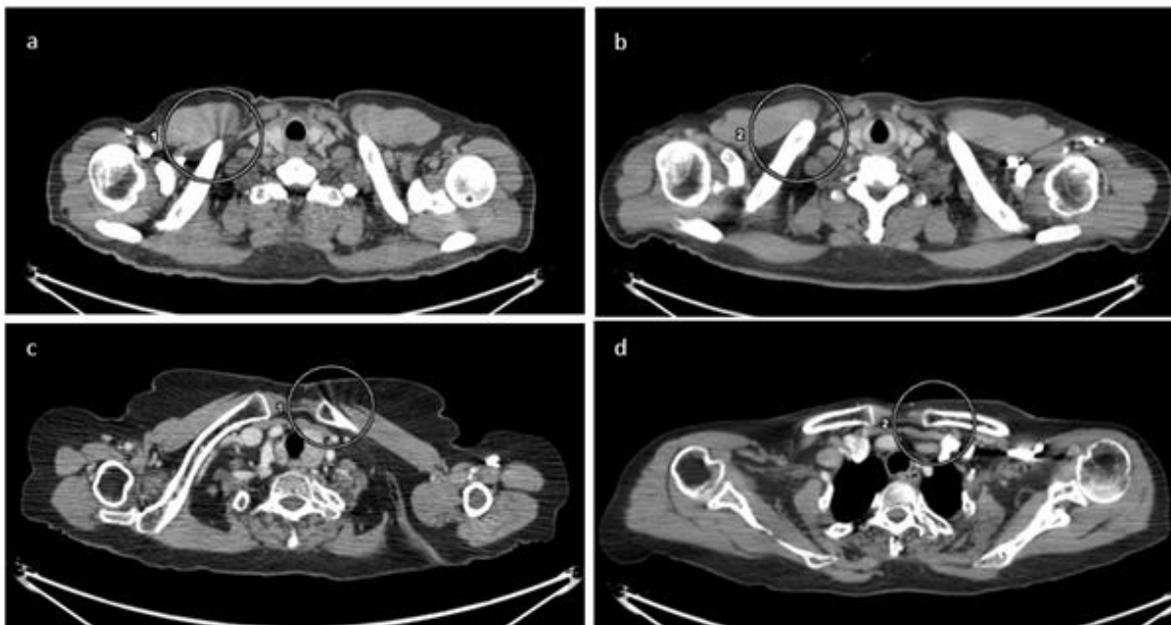
of all CT and PET-CT scan-based patients. Then GE engineer suspected on the CT acquisition, reconstruction methods and we decided to review the CT parameters like scan type, rotation time, recon mode, recon type, pitch, noise index and all. Our review revealed difference in CT reconstruction type and rotation time.

In the earlier protocol the standard recon type and rotation time was 0.6sec with standard recon mode which

was now changed to soft recon type, IQ enhance recon mode with rotation time of 0.7sec.

Figure 2: (a)&(c) axial images of two different patients showing streaking artifacts at clavicle bone (encircled) and (b)&(d) axial images of same patients after changing parameters

The streaking artifacts on trans axial CT images due to an unusual cause such as improper acquisition parameters which does not require expensive replacement of

the detector module, CT hardware parts and also not much of significant down time. This type of artifacts can be avoided by maintaining locking system of the standard protocols prescribed by the manufacturer.

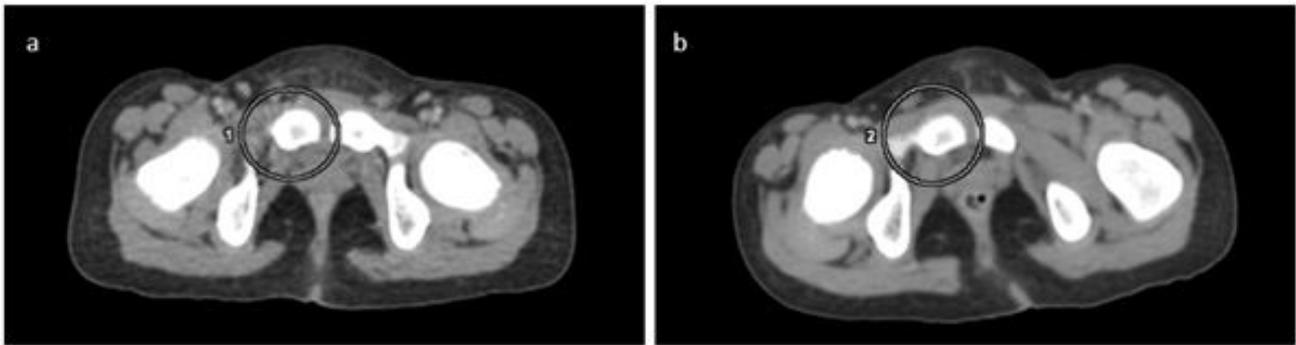
Figure 3: (a) axial image of another patient showing streaking artifact at right pubic bone (encircled) and (b) axial image of the same patient after changing parameters
