Explosion and Fire Caused Due to Storage of Maleic Anhydride and Potassium Hydroxide Together

An incident of explosion followed by fire was reported in a warehouse in Bhiwandi (Maharashtra), which leases storage space to the stockists for keeping miscellaneous chemicals. Forensic investigation was carried out to find the cause of fire by examining the scene of fire, thoroughly. It was found that 800 bags of maleic anhydride and 200 bags potassium hydroxide, which are incompatible, were stored side by side along with other chemicals in the warehouse. After thorough Investigation, it was concluded that violent explosive exothermic reaction could have taken place between maleic anhydride and potassium hydroxide, causing an explosion and fire.

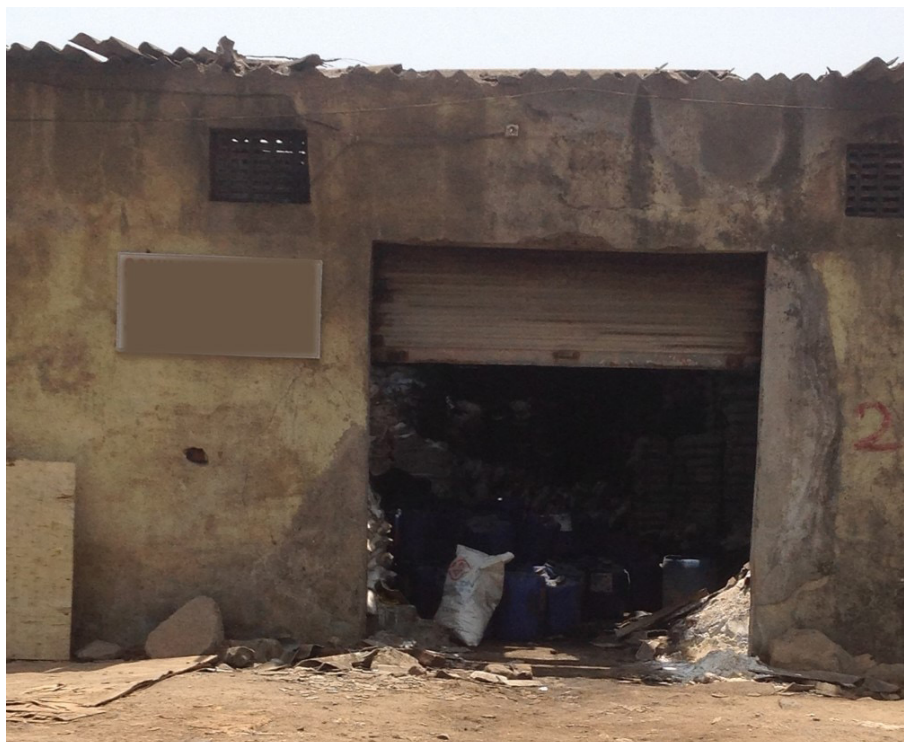
The fire affected warehouse was facing north (Figure 2). Extensive burning was observed on north western side of the warehouse i.e., zone 8 and 9. The asbestos roof above the chemical bags stored there, was found to be blown off (Figure 3) and the bags

Figure 2: The front view of the fire effected warehouse

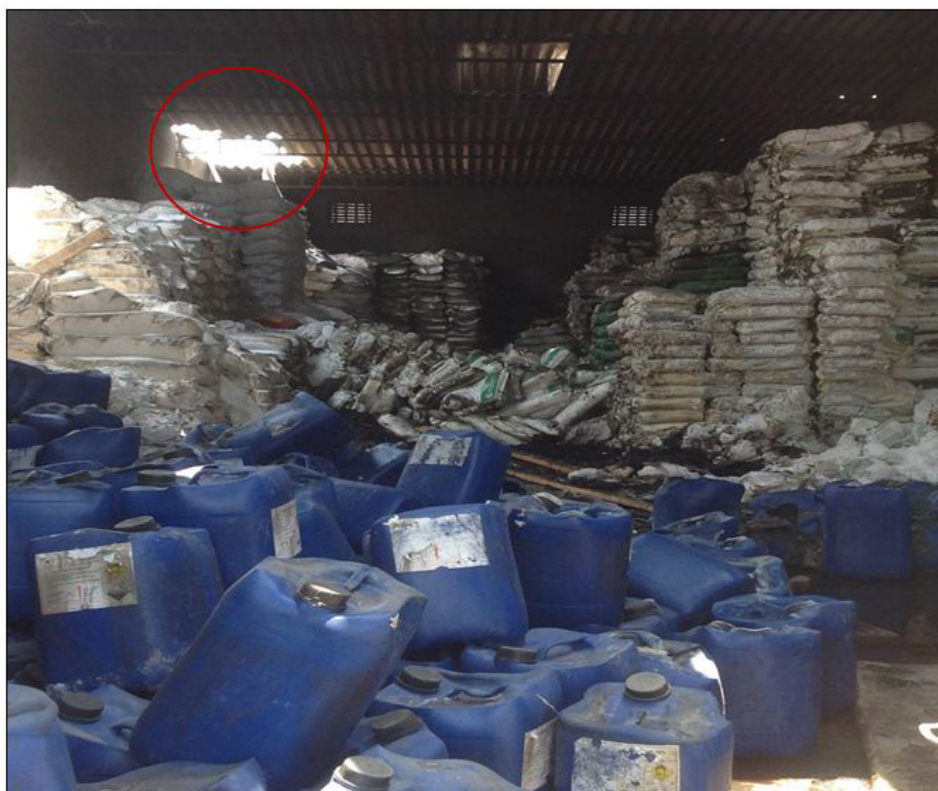
were burnt/ fused to various degrees. Further, the effect of fire was found to be maximum in zone 8 and 9 (Figures 3 and 4). From the examination of the records and interaction with ware-

Figure 3: An overview of the fire effected warehouse showing the blown off roof over the area where maleic anhydride was stored indicating a low intensity explosion.

As the maximum damage occurred in zones 8 & 9 which extended to the adjoining zones 10 & 15 and the fact that the roof made up of asbestos sheets above zone 9 and zone 15 were blown off, indicates a low intensity explosion. As per ware house keeper, in zones 8 & 9, 200 bags (of 50 kg) of potassium hydroxide (Caustic potash) and 800 bags (of 25 kg) maleic anhydride were stored. All the bags were totally fused or burnt. Hence it is inferred that the fire originated from this area i.e., zone 8 & 9.

Due to the explosive force, the roof of the ceiling was blown off over zones 9 and 15 (Figures 3 and 5). The fire generated in the explosion burnt/fused all the 800 bags of maleic anhydride, 200 bags of potassium hydroxide and 480 bags of sodium sulphate stored in zones 8, 9 and 15. The fire so generated spread to the neighboring zone 10 where sodium carbonate (Soda ash) stored was also found fused.

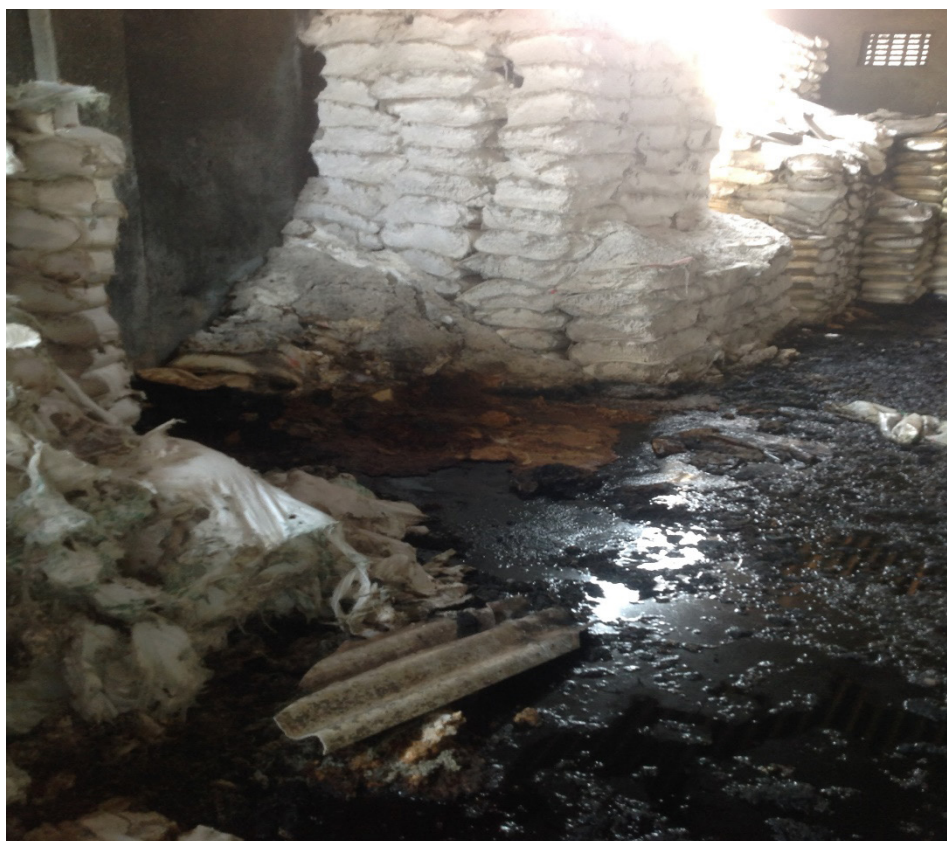
house keeper, it was found that 200 bags of potassium hydroxide (Caustic potash) and 800 bags of maleic anhydride were stored side by side in these zones 8 and 9 respectively.

Figure 4: A view of the area after the incident of fire where the 200 bags of potassium hydroxide stored was completely burnt

Maleic Anhydride undergoes violent explosive exothermic decomposition reaction producing carbon dioxide in the presence of strong base such as Potassium Hydroxide [14]. As potassium hydroxide and maleic anhydride were stored adjacent to each other in zones 8 & 9, they must have come into contact with each other. Being incompatible, potassium hydroxide and maleic anhydride must have undergone violent explosive exothermic reaction generating fire. Hydrolysis of maleic anhydride followed by neutralization with an alkali metal hydroxide results in maleate salt formation [15].

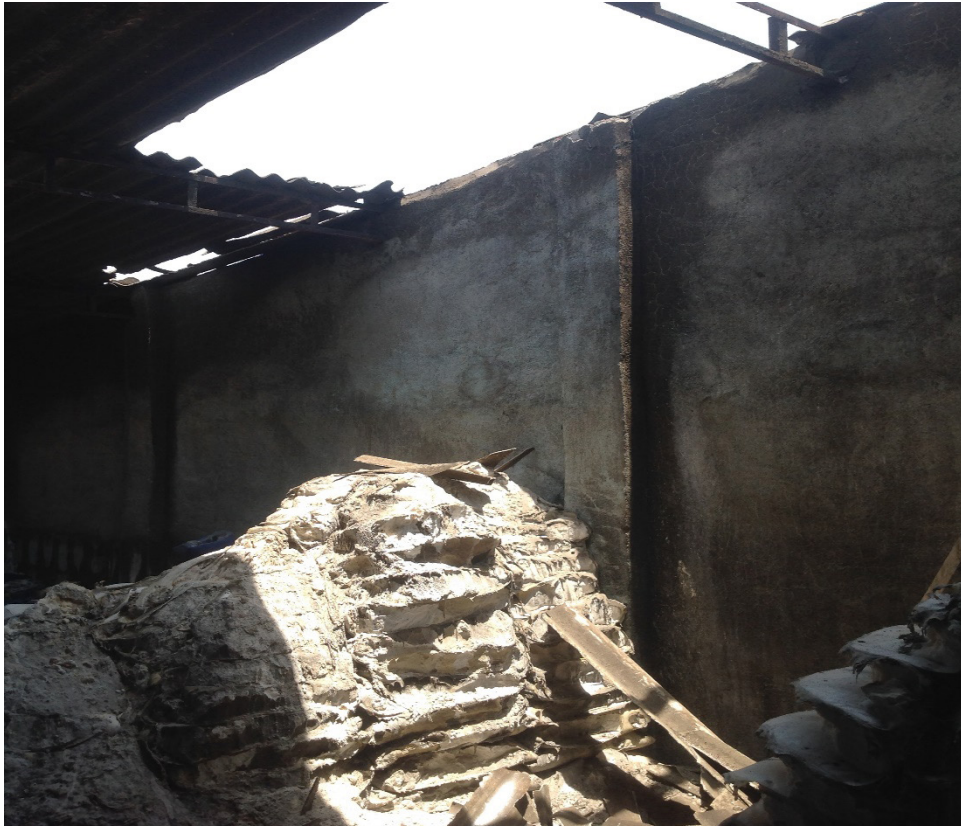
Some of the bags of sodium carbonate (Soda ash) stored (adjacent to zones 8 and 9, towards northern side) in zone 10 were also found fused. All the 480 bags of sodium sulphate stored in zone 15 (Figure 5), adjoining the completely affected zones 8 & 9, towards the eastern side were also found fused. The asbestos roof above this zone was also found to be blown off.

Figure 5: A view of fused Sodium Sulphate bags. The blown off roof due to low intensity explosion can also be seen in the figure

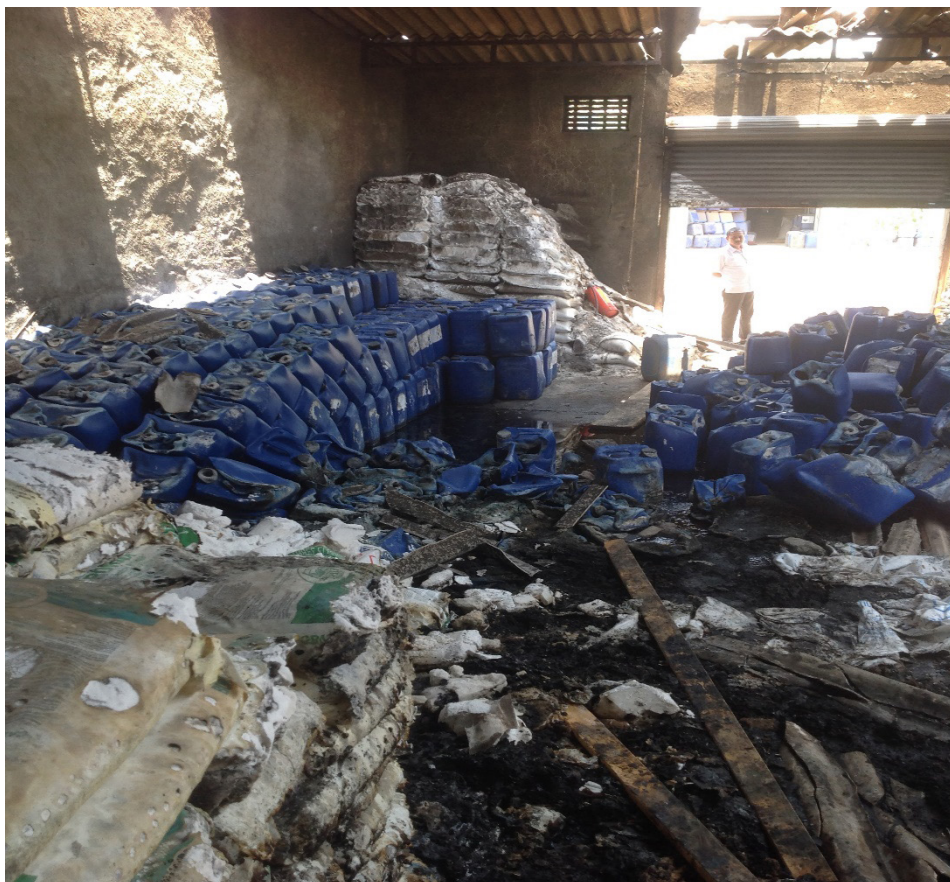
The sodium sulphate stored in zone 1 & 12 was marginally affected by fire. The hydrogen peroxide cans stored in zones 2 & 13 were partially damaged due to fire (Figure 6). The bags of trisodium polyphosphate, in zone 3, sodium sulphate stored in zones 4, 5 & 6 were partially affected. Sodium sulphate stored in zone 7 was also partially fused. Potassium carbonate in zone 11 and some bags of sodium carbonate (Soda ash) stored in zone 10 were marginally affected by fire (Figure 7). Borax stored in zone 17 & 14, bleaching powder in zone 16 were marginally affected by fire.

Figure 6: A view of the partially effected Hydrogen Peroxide cans stored away from the origin of fire

Among the remaining chemicals stored in the warehouse, bleaching powder [16] and hydrogen peroxide [17] are known to be reactive and cause explosions and fire under certain conditions. However, as these were stored in zone 16 and zone 2 & 13 respectively far away from the origin of fire and were partially affected by fire, their role in causing the fire accident is ruled out. The remaining chemicals are stable and non-flammable; they were partially affected due to external fire.

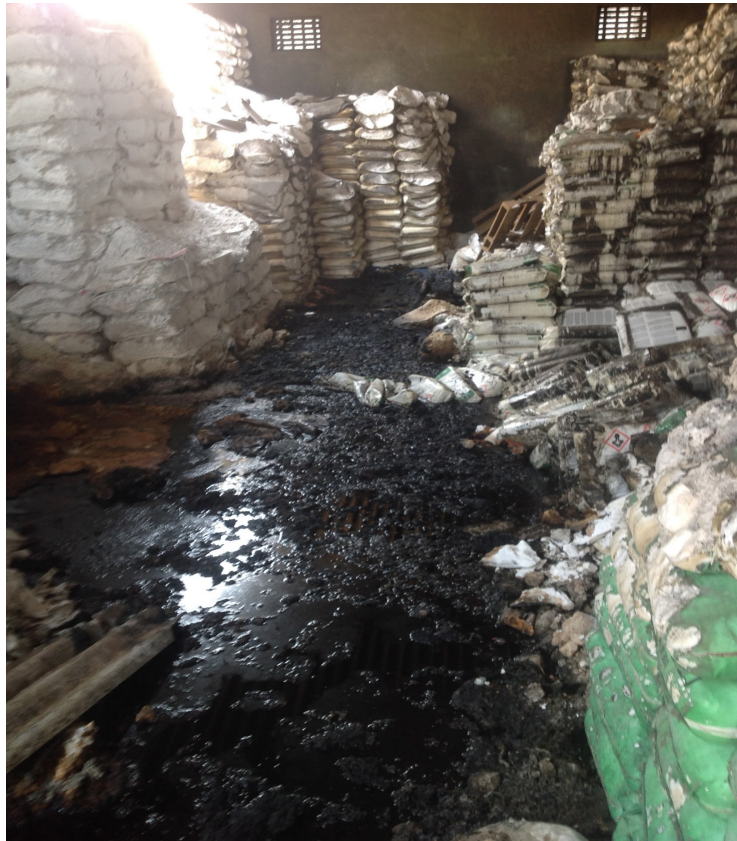
Figure 7: A view of the marginally fire effected potassium carbonate and sodium carbonate bags stored far away from the origin of fire
